# Holdtight® 102

Salt Remover/Flash Rust Preventor

## Case History for Surface Preparation of Steel Cargo Hold

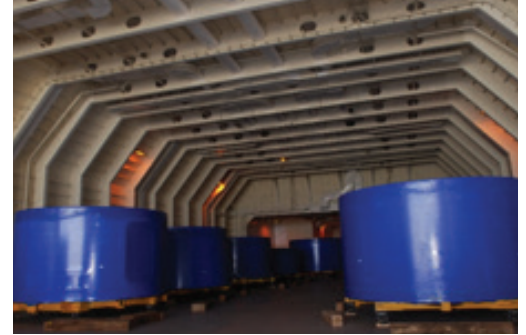
The pre-washed steel had salt readings of 7-15ppm. The desired level was 5ppm or lower.

As the work was carried out in the winter, conditions were harsh and humidity was likely, so the surface needed to be entirely free of salts and contaminants to avoid flash-rusting.

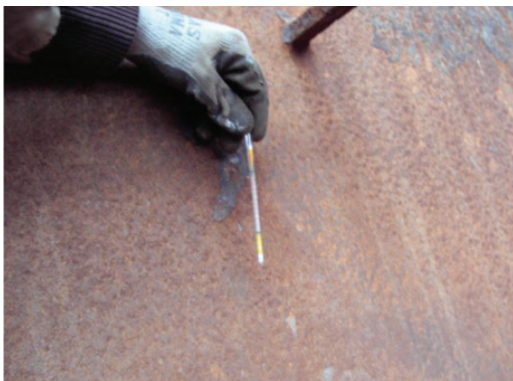
Correct application of HoldTight® 102 meant that, when the steel was re-tested the following day, chloride levels had dropped to 1ppm. The desired chloride level was 5ppm or lower so our customer achieved better results than expected or required.

Hold #4 after ½ of the cargo hold has been water washed by Marine Clean. HoldTight® 102 was added to the clean water to assist in lowering the chloride content. A random area was tested, on the stern bulkhead. Chloride content was found to be 1ppm. N.B. White is chlorides, pink and yellow is ok.

The diluted HoldTight® 102 was used during power washing. Once the steel is dry, it is ready to be primed and coated.
