Case History for Surface Preparation of Steel Boat Hull

HoldTight® 102 Salt Remover / Flash Rust Preventer

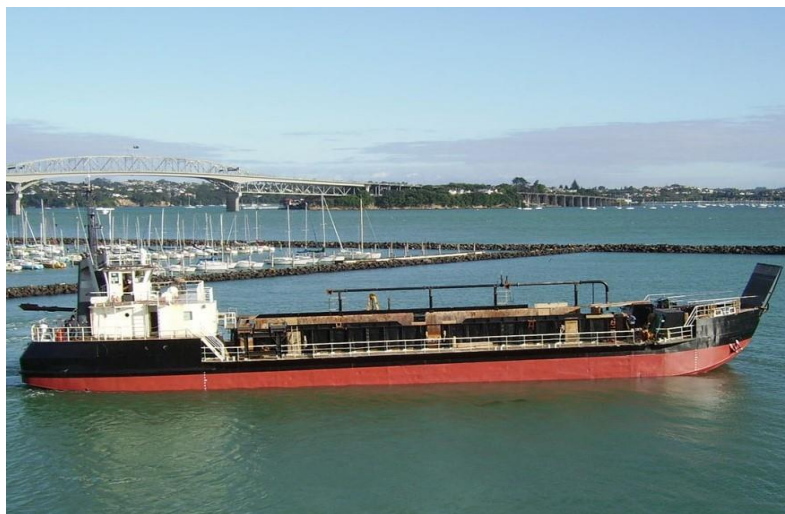
Customer is a coating application contractor based in New Jersey. Being in such close proximity to the coast, our customer frequently deals with coating maintenance of boats and other marine vessels. Properly preserving the integrity of the steel that these boats are made of is essential in optimizing the vessel's productivity and ensuring the safety of the individuals on board.
